Manhole Inspection Summary

Manhole # S65M__003MH

Location Address: **5801 O'Donnell St.**

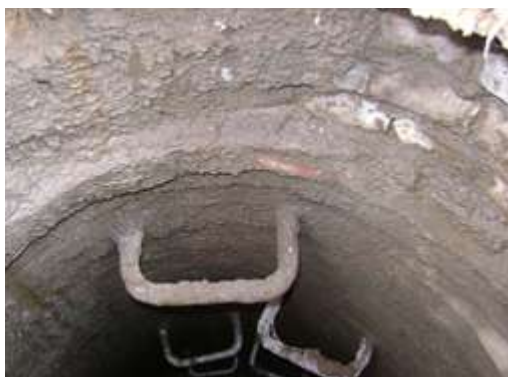
Defect 3

Infiltration: ☐ None ☒ **Joint** ☐ Cracks ☒ **Mortar** ☐ Roots ☐ Wall

infiltration evidence in barrel

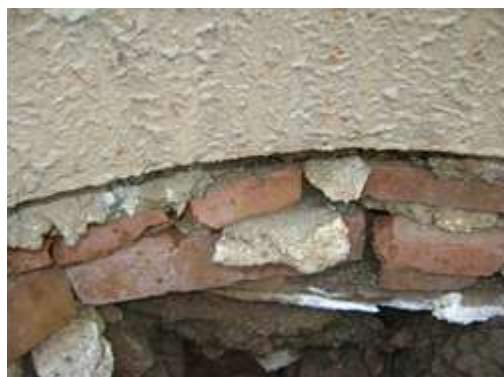
Defect 2

Condition: ☐ Sound ☐ Cracked ☐ Root Intrusion ☒ **Loose Brick** ☒ **Deteriorated**

loose bricks at frame adjustment

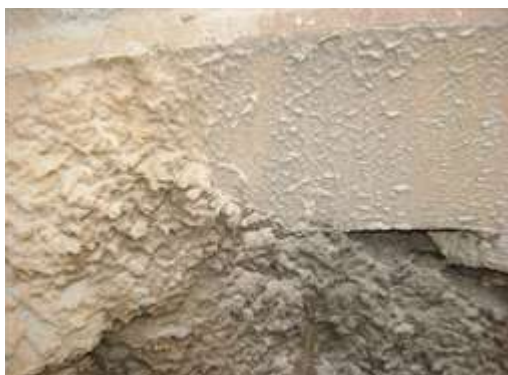
Defect 1

Infiltration: ☐ None ☒ **Joint** ☐ Cracks ☒ **Mortar** ☐ Roots ☐ Wall

infiltration at frame

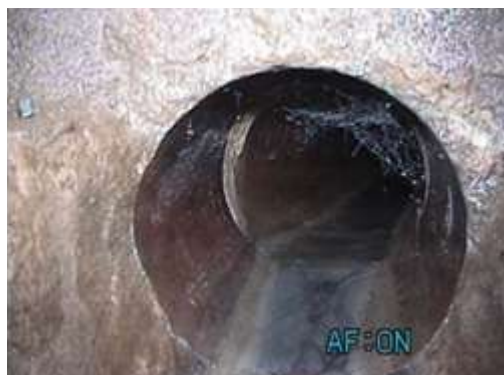
Defect 4

joint offset angular 7:00-4:00 incoming 9 o'clock

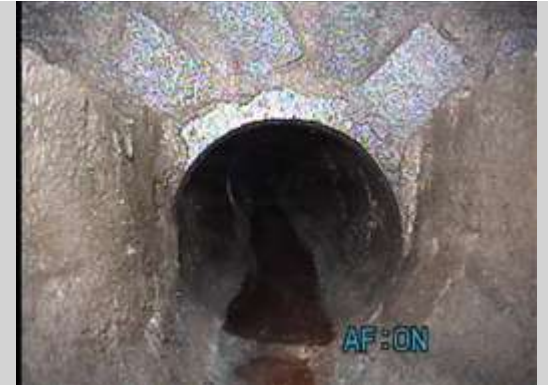
12 O'Clock Outflow

Pipe Height: **8.4** (in.) Rod and Bar (Angled)
Pipe Material: **Clay** ☐ Pipe Lined
Invert Depth: **11.17** (ft.) Flow Characteristics: **Fast**
Deposits: ☒ None ☐ Mud ☐ Sludge ☐ Debris ☐ Grease
Silt Depth: (in.) Deposits Extent:
Infiltration: **None** Pipe Seal Cond: **Sound**

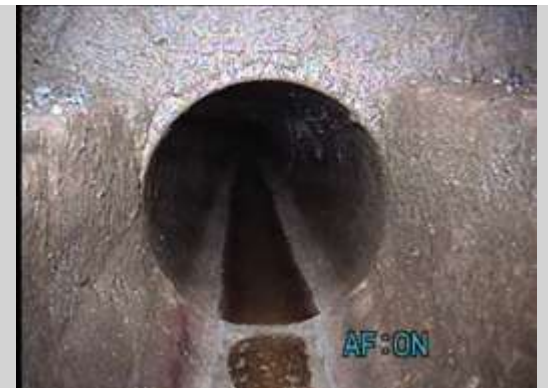
6 O'Clock Inflow

Pipe Height: **8.4** (in.) Rod and Bar (Angled)
Pipe Material: **Clay** ☐ Pipe Lined
Invert Depth: **10.71** (ft.) Flow Characteristics: **Fast**
Deposits: ☒ None ☐ Mud ☐ Sludge ☐ Debris ☐ Grease
Silt Depth: (in.) Deposits Extent:
Infiltration: **None** Pipe Seal Cond: **Sound**

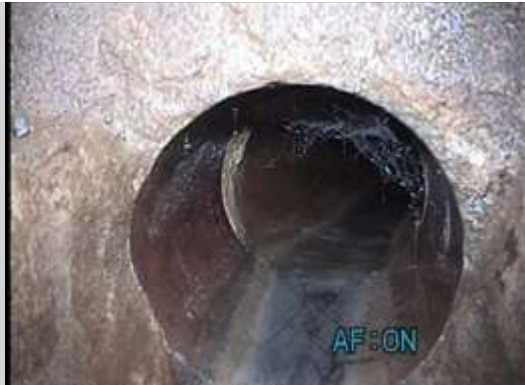
9 O'Clock Inflow

Infiltration: **None** Pipe Seal Cond: **Sound**
